# ARLINGTON COUNTY CUSTIS TRAIL NEEDS ASSESSMENT & PRIORITY IMPROVEMENTS STUDY

The *Arlington County Custis Trail Needs Assessment and Priority Improvements Study* provides a technical review and documentation of current Trail conditions and connections and equips the County with targeted recommendations. The purpose of the project is to document the conditions of the Custis Trail and its connections, and to identify both immediate and longer-term opportunities for investment in improvements that support the County's vision for a safer multimodal transportation network and accessible open space and recreation.

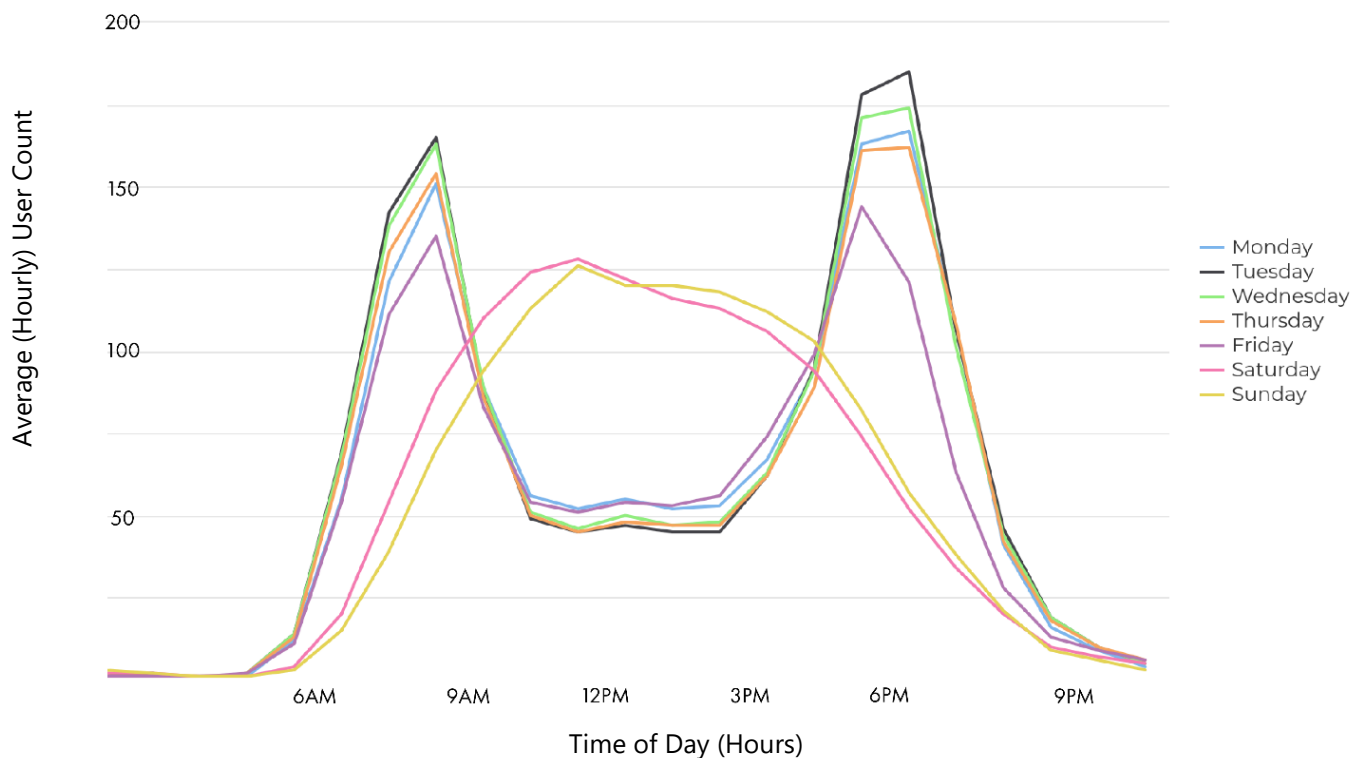
Figure 4 Custis Trail Average Hourly Volumes by Day of the Week at the Rosslyn Counter (2009 - 2024)

As shown in the graph, the Trail typically experiences peak volumes between 7 and 9AM, and 5 to 6PM, peaking at around 175 users per hour. (Note: This includes trail count data collected throughout the COVID-19 pandemic and resulting lockdowns, during which typical peak times and commute patterns were upended). This hourly volume provides a baseline for determining an appropriate width for the Custis Trail now and in the future, using the Trail Design Guidance found in the Local Plans and Design Guidance section below.

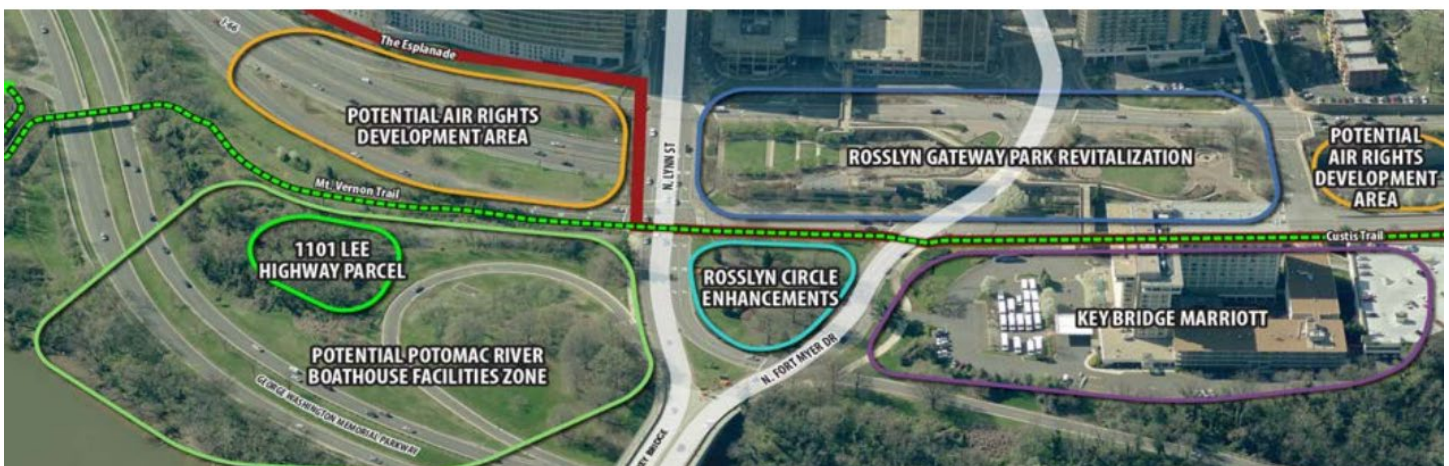
**Figure 14 Development Opportunities at the intersection of Lynn Street, Langston Boulevard, the Custis Trail and the Mount Vernon Trail** (Source: *Rosslyn Sector Plan*)

- Improving the intersection of Lynn Street, Langston Boulevard, and the Trail; and
- Studying the feasibility of a Custis Trail underpass at Lynn Street.

The context for these recommendations is reflected in the development opportunities graphic shown in Figure 14.

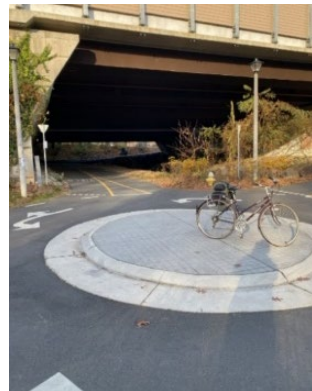
Figure 25 Custis Trail Roundabout

The segment begins with a steep slope leading to a roundabout before crossing I-66 (Figure 24). The conditions on the south side of the Trail between the underpass and the next I-66 overpass feature limited wayfinding and poor lighting; on the north side of the Trail, the Trail narrows (10-foot width), with no buffer between the Trail and the abutting wall or drainage ditch (Figure 25).

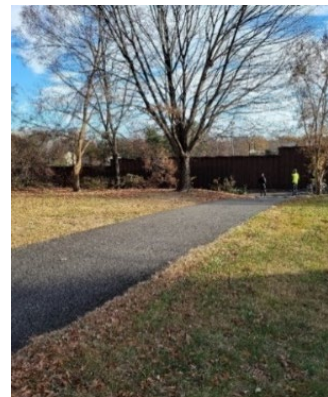
Figure 27 Park-like Area by 10th Street

The Trail between Harrison and Frederick Streets is in good condition, aside from lack of lighting available especially under the bridge. The segment would benefit from new trail amenities, especially at the connection to 10<sup>th</sup> Street where features like seating, trash and recycling receptacles, or other amenities could support the existing park-like atmosphere (Figure 26). Limited or outdated wayfinding signage between Frederick and Edison Streets needs improvement, including new directional signage at this 10<sup>th</sup> Street park area and opposite of Frederick Street.

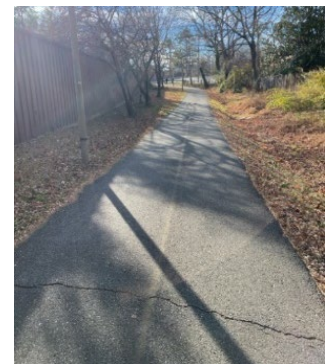
Figure 26 Trail from Frederick to Edison

The width of the Trail narrows to a 9.5-foot width and is further narrowed by light poles and trees on the south side of the Trail, and drainage to the north side, that both physically and visually constrains the Trail (Figure 27). The team identified curb ramps with accessibility issues at Harrison Street, Frederick Street, and 10<sup>th</sup> Street.

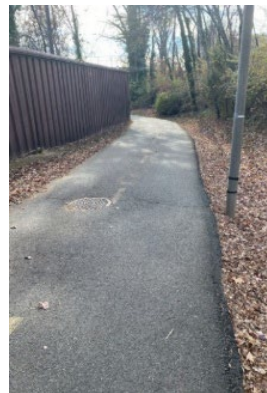
Figure 31 Blind Curves on Trail

The Trail segment is 10 feet wide but feels narrower due to the lack of buffer between the wall and nearby light poles (~1 foot from the pavement edge). These conditions also create blind curves for trail users (Figure 28). A lack of signage at the George Mason Drive exit is confusing for those exiting the Trail; this access point is further complicated by the presence of DWS leading to a bike lane (the crosswalk is across the intersection and to the north, see Figure 29). There are several pavement condition issues, including an expansion joint on the bridge over I-66 and pavement with cracks or root heaving throughout the segment, including a particularly narrow exit at Buchanan Street (Figure 30).

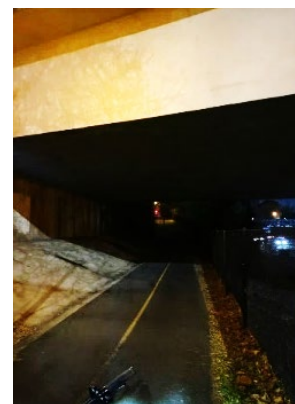
Figure 28 Quincy Street Underpass

While there were noted areas of poor lighting in the segment, the lack of lighting was most notable at the North Glebe Road and Quincy Street underpasses (Figure 32 shows the Trail at the underpass at dusk).

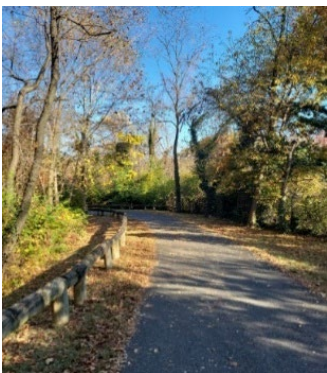
Figure 36 Example Trail Cross-Section

This segment featured a large amount of root heaving and associated pavement condition issues where the Trail is damaged or physically disrupted by roots. The width ranges from 9-9.5 feet wide but does appear to have usable space near the Trail (Figure 33).

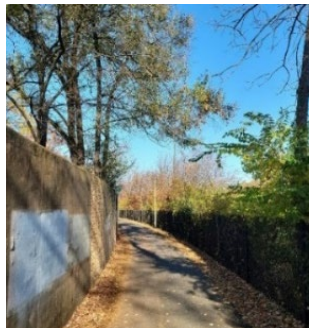
Figure 35 Trail Curves and Condition

There were several wayfinding and signage observations in this segment, including missing Custis Trail signage, small and unclear exit signs at Nelson and Lincoln Streets, lack of warning signage for blind curves, and observing that the exit to Quincy Street does not mention the street name, but does reflect nearby destinations. Figure 34 presents one section between 17<sup>th</sup> and 20<sup>th</sup> Street with a blind curve and limited shy space along the wall.

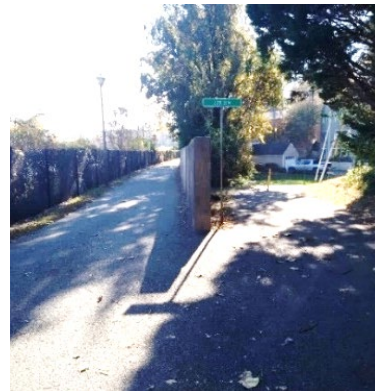
Figure 34 Blind Entrances at 20<sup>th</sup> Street (left) and Spout Run (right)

Two entrances in this segment — the entrance at 20<sup>th</sup> Street and the entrance ramp from Spout Run — feature blind corners that can pose challenges to people accessing and exiting the Trail (Figure 35). When the Trail continues to travel under the expressway the width is narrow and bounded by high barriers on both sides that further reduce usable width (Figure 36). The team noted several blind curves, including a curve complicated by nearby parking (behind the shopping center) where parked cars overhang into the trail area. Other conditions in this segment include unclear signage and oversized or unprotected drain grates that need to be replaced.

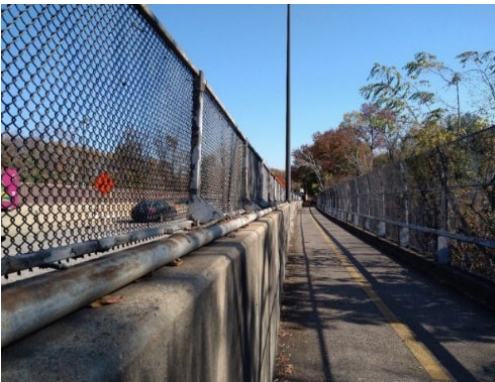
Figure 38 Spout Run Bridge

The team noted several and significant flooding and drainage issues along this segment, including design and maintenance challenges. In particular, the team noted the existing stormwater conveyance moves water towards the highway wall (by Veitch Street), as well as areas where the retaining wall drains to the trail (by Adams Street) but the trail lacks drainage.

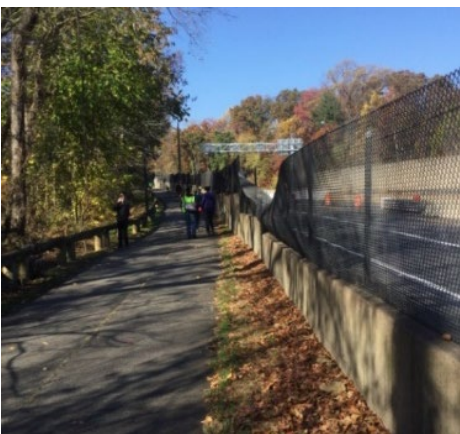
Figure 37 Near 21st Street Overpass

Segment 7 runs parallel to I-66 and presents the most perceived exposure to the roadway. At Spout Run Bridge (Figure 37) the Trail is very loud due to expressway traffic. The 21<sup>st</sup> Street overpass (Figure 38) is similarly loud and has several areas with significant fencing damage that influences the actual and perceived buffer between the Trail and the roadway.

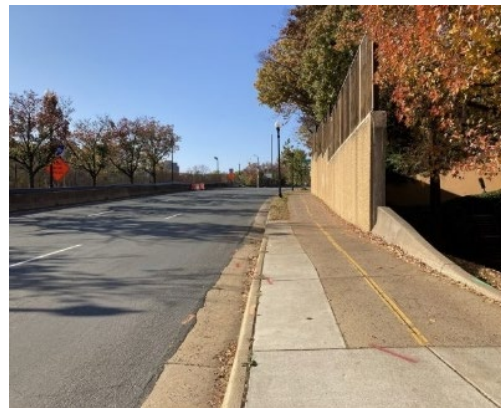
Figure 39 Narrow Trail

The Trail width in front of the sound wall is very narrow at only 7 feet wide (Figure 39). The poor visibility of westbound trail users and steep slope present safety hazards to trail users, especially as the intersection of Langston Boulevard and North Quinn Street is a high-crash intersection.

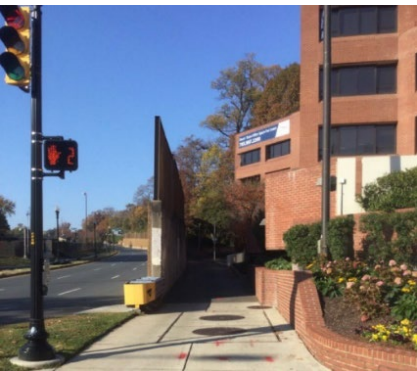
Figure 41 Trail and the Tall, Adjacent Walls

The sound wall and retaining walls in this segment are very high, reducing the visual line-of-sight within and beyond the trail (Figure 40). This makes the trail feel narrower than its 10-foot width; in addition, the lack of visibility reduces the “eyes on the trail” and ability to see and be seen by other modes. Trees and poles placed close to the trail edge similarly reduce the available space for trail users, and this is further complicated by steep drop-offs at the trail edge particularly between Oak Street and Quinn Street (Figure 41).

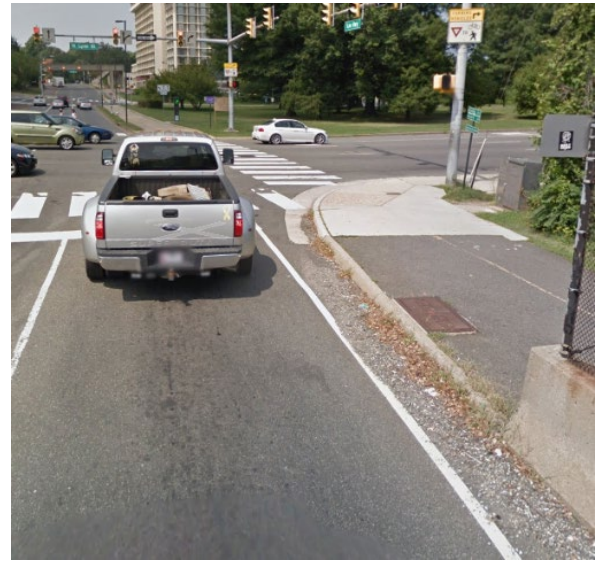
Figure 42 Right Turn Conflict at Mt Vernon Trail Junction

One spot in Segment 9 that comes up frequently in public comments and past studies is Rosslyn Circle where the Custis Trail ends, and the Mt Vernon Trail begins (Figure 42). The high number of right turns from the Parkway onto Lynn Street makes it difficult for trail users to cross. A dynamic “No Right on Red” sign gives trail users partially protected time to cross, but there are still dual right-turn conflicts, and the intersection remains a Vision Zero Hot Spot due to the high number of pedestrian and bicycle crashes.

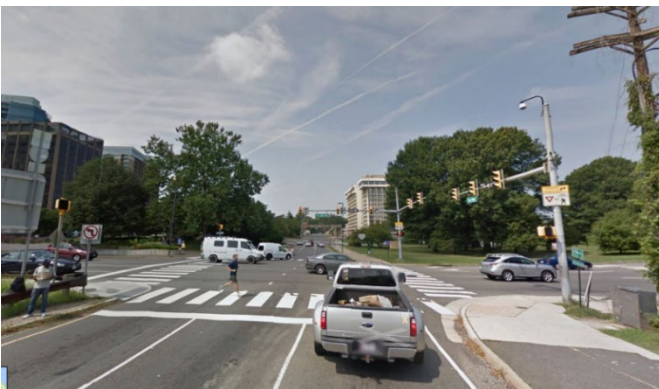
Figure 55 Intersection of North Lynn Street

The intersection of the Trail and North Lynn Street that has been evaluated in several local planning documents and emphasized in the public feedback collected for this project. Figure 54 depicts the turning conflicts that evaluated in the 2019 Lynn Street Esplanade and Custis Trail Improvements Report. This Report also assessed the feasibility of continuing the Trail as a tunnel beneath North Lynn Street. The evaluation considered three alternatives: an open excavation and two trenchless tunnel options.

The Report noted that further analysis including a geotechnical survey would be required for next steps and conceptual design. While a tunnel could be considered as a long-term proposal, other safety improvements, including signal changes and facility improvements (at-grade) are short-term approaches.

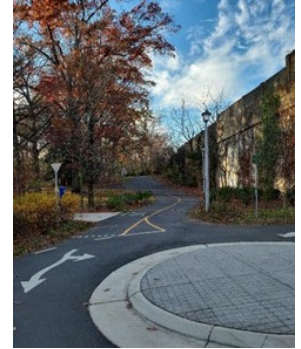
Figure 54 Roundabout

As the Trail moves past Bon Air Park, a small roundabout (Figure 55) directs users to follow the Trail under I-66, or to continue straight (east) and complete the Trail spur. This roundabout is a noted safety concern, with many survey participants reflecting on the facility and perceived unsafe experiences.

Short-term recommendations include improvements to make the turning movements more clear, reduce confusion, and reduce conflicts between users. Regrading the hill that leads to the roundabout would be a longer-term (and higher cost) option.

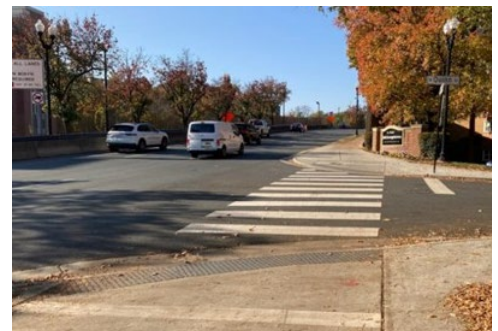
Figure 56 Intersection of Langston Boulevard, Quinn Street, and the Trail

Finally, the intersection of Langston Boulevard and Quinn Street is a noted safety concern of the County and a high-crash intersection as identified through Vision Zero efforts. The Trail crossing this intersection (Figure 56) experiences high risks of conflict with turning vehicles and a challenging negotiation of movement between different users. Short and long-term recommendations look to improve visibility of Trail users and pedestrians crossing the intersection.

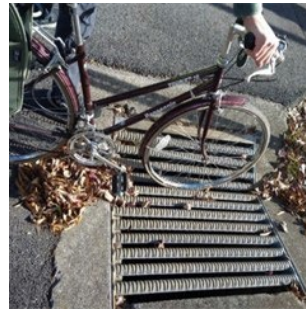
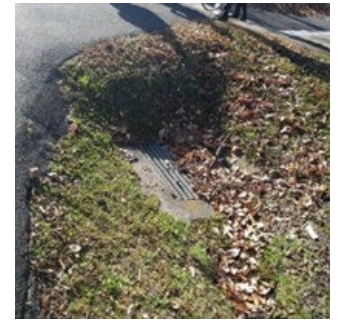
The majority of the Custis Trail runs through or adjacent to areas that experience localized flooding, especially along the segments with the soundwall or other physical features that convey run-off. Due to the extensive storm water system, most of the Trail drains well in its current condition. However, there are some spots and experience ponding that could present a hazard for trail users. These locations are included in the list of specific recommendations provided as Appendix C.

To mitigate these issues, the areas could be improved with regular cleaning to ensure the trail and path of water conveyance is clear of debris, or with new and improved infrastructure as part of a trail widening project. Potential relocation of select stormwater infrastructure may be recommended based on the trail design and to address safety concerns. Any movement, redesign, or upgrades to stormwater infrastructure must adhere to the Arlington County Code (Chapter 60, Stormwater Management) and state regulations, and should align with the County's *Stormwater Master Plan* and other local or watershed plans.

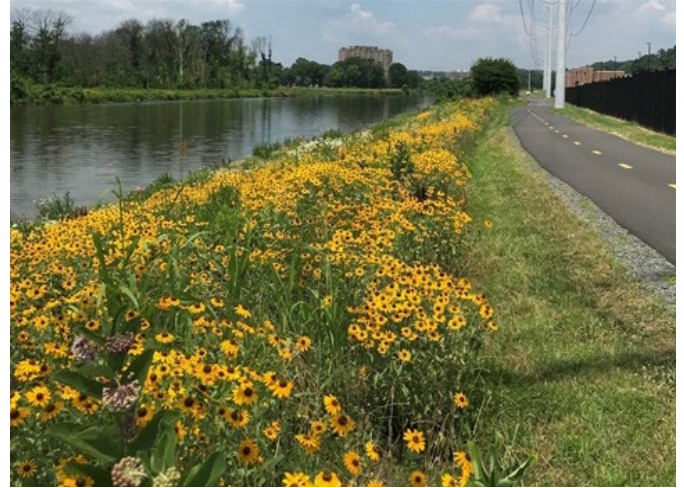
**Figure 59** Example of a Rain Garden along W&OD Trail

There is a natural conflict between low-impact development and designs and advancing the safety of the trail through widening. Widening the trail will necessarily increase the impervious surface area by reallocating 2 feet of trail edges (typically grassy area) as a paved trail. Long-term plans for this process must include adequate stormwater plans to mitigate this increased impact and improve the capacity of the trail area's stormwater infrastructure. In certain sections of the trail there may be the potential to site rain gardens as outlined in the County's Green Streets program. Rain gardens enable stormwater to flow into an area and slowly filter to a drain. This process reduces runoff by slowing the filtration process, while the garden component offers aesthetic and environmental benefits.

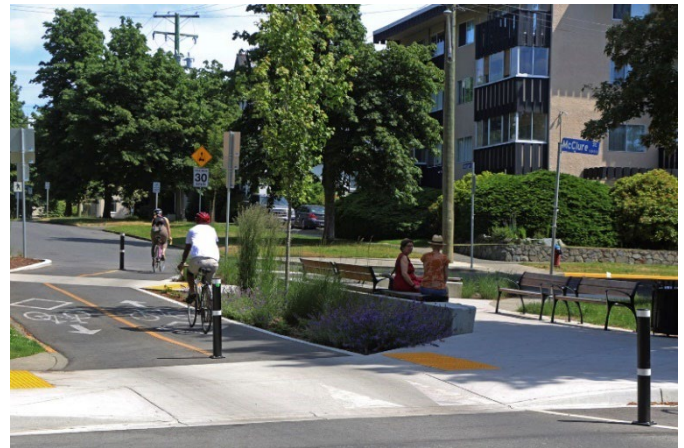
**Figure 60** Example of Stormwater Management along a Trail in Victoria, BC (Source: Toole Design)

Site planning or design for the Trail should consider and review the potential stormwater impacts and incorporate elements that will benefit the ability to effectively manage stormwater and other flooding events. Designs should prioritize low-impact development (LID) which supports natural infiltration and bioretention to reduce stormwater issues. Examples include rain gardens to capture, filter, and use water; rain barrels to capture and store water; and pervious surface treatments such as porous pavement to improve the absorption of water (rather than runoff). The [Environmental Design Guidelines](#) developed for the Great Rivers Greenway in St. Louis, MO, presents examples of cross-sections and designs to incorporate stormwater management infrastructure below or along a trail.

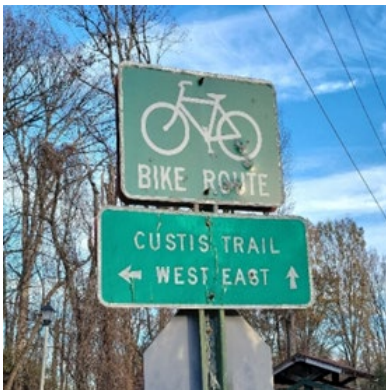
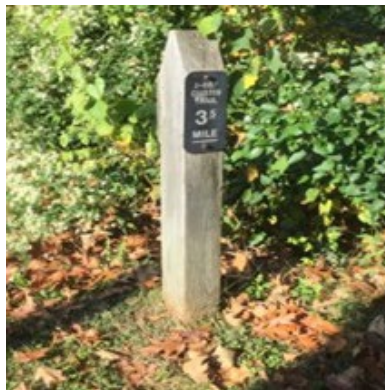
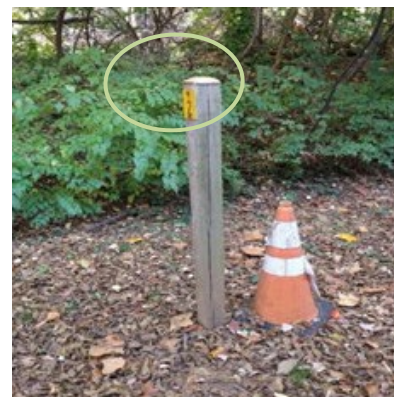
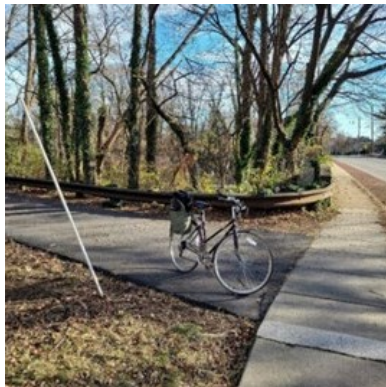
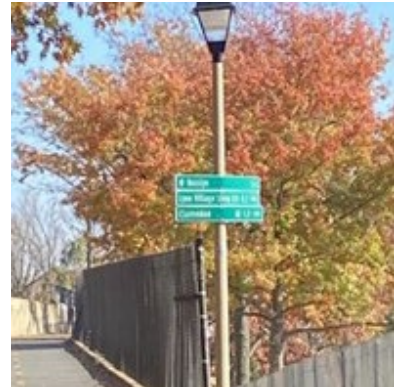
Figure 61 Sign and Wayfinding Needs

The Custis Trail contains an extensive system of wayfinding signs. Most are the standard green MUTCD and County style, including a large bike route sign and smaller destination subplates. However, many signs are missing, faded, or vandalized and need to be replaced. The short-term recommendation map and list in the appendix includes a list of specific wayfinding sign improvements for new and replacement signs. In addition to the green wayfinding signs, there is an assortment of posts with mileage numbers. These posts should be standardized and expanded. Appendix C of the Wayfinding Manual provides a sign installation worksheet.

Standardize and expand mile markers and confirm information provided

Address missing signage

Add safety/advisory signs

Add information for trail users

1. Meets the design and placement standards;
2. Signs that require repair or maintenance (e.g., damaged or illegible due to graffiti or signpost issues);
3. Signs that do not meet Wayfinding Manual standards;
4. Locations that do not meet current wayfinding needs (e.g., missing at trailhead or incorrect destinations, or gaps at areas that would benefit from safety alerts such as "curve ahead").

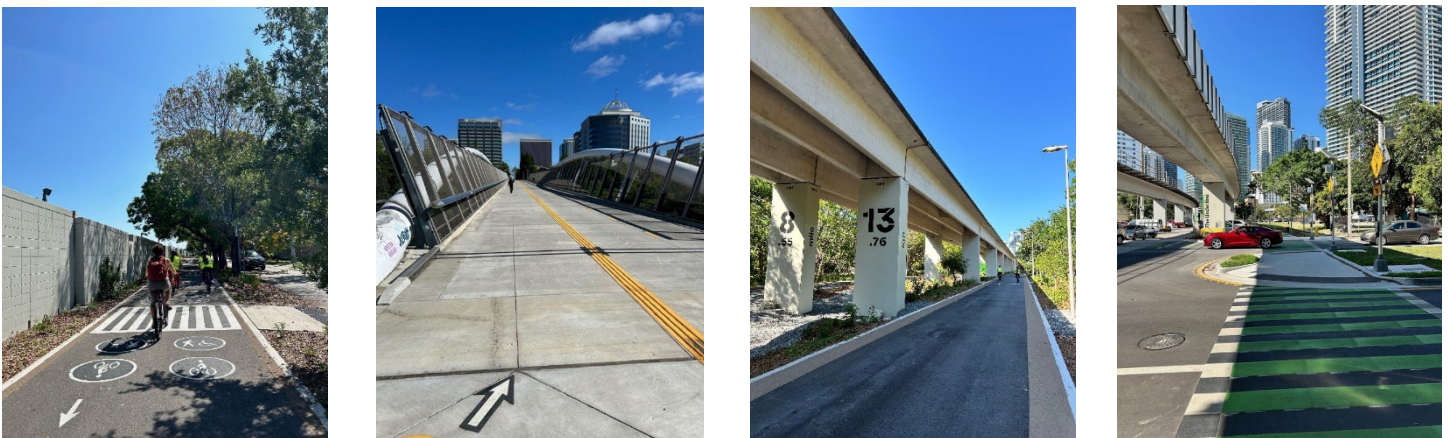
**Figure 62 Examples of Trail Wayfinding Design: Pedestrian Crossing (left) Modal separation (center), Mile marking on elevated structure, Green pavement crossing treatment.** (Source: Arlington County)

**Asphalt Treatments:** Pavement markings can be an intuitive wayfinding tool to clearly define the space or direct movements of trail users. Asphalt treatments can provide highly visible information to all users, such as alerting to major crossings and areas where trail users will interact with other modes, and highlighting connections.

As shown in the images below, painted striping along trails can be used to separate two-way travel and direct trail users through complex or confusing segments (e.g., a colorful centerline to identify the path of travel). Green pavement markings on roadways at trail crossings is a visible cue to alert drivers to expect trail users. Similarly, well-defined pedestrian crossing areas are critical for safety.

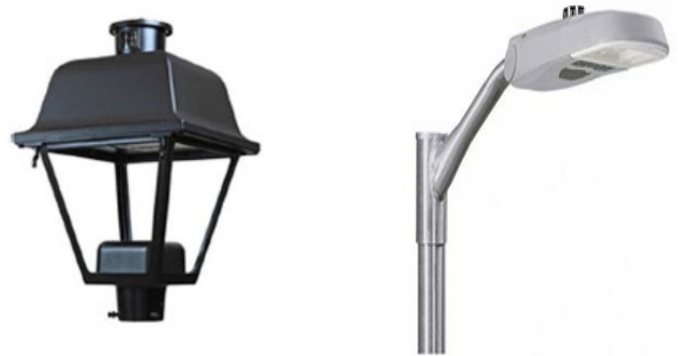
**Figure 63 Dominion Energy Lighting Example: Cutoff Colonial, a dark-sky version of the existing Colonial lamps along the Trail, and Cobra Lighting** (Source: [www.dominionenergy.com/virginia/products/lighting-fixtures](http://www.dominionenergy.com/virginia/products/lighting-fixtures))

The County should prioritize low wattage cobra (e.g., Type II 70W equivalent), and —since DE does not include any wall or bridge attachment products —designs that involve mounting onto existing structures would need to be carried out using County-owned light fed from meters.

*Lighting Design:* Lighting updates in the near-term should focus on addressing issues with the existing light poles and bulbs while exploring longer-term opportunities to replace lighting. Replacements or reinstallation of existing light infrastructure should follow the photometric design outlined in the [County's Lighting Specification](#) (2023) and should reflect coordination with utility providers (such as Dominion Energy or DE) to meet lighting standards and designs. Photometric design should use options available in the DE catalog, with iterations using colonial and cobra style lighting to achieve the minimum required lighting level using the least numbers of poles.

Secondly, these designs should incorporate IDA principles (see Trail Design Guidance, and specifically Action Step 3.5.1.2 of the County's Forestry and Natural Resources Plan which recommends incorporating IDA principles at the time of bulb replacement for existing public infrastructure).

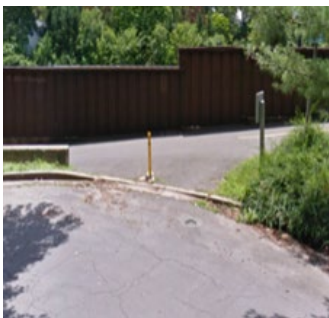
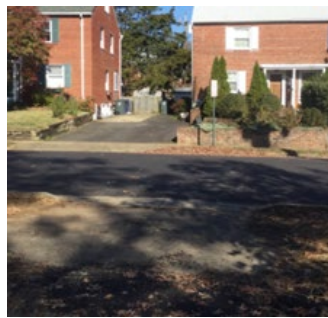
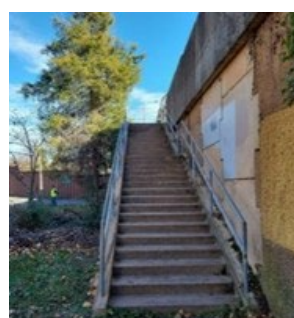
Figure 65 ADA Infrastructure Needs - Example Locations

Throughout the study area the team identified facilities and connections not in compliance with ADA or PROWAG standards as accessibility gaps. Many of the recommendations center on the improvement of available ramps to the trail. Near-term projects include improving ramps at trail access points, such as pavement repair and ramp grade (e.g., addressing ramps that are too steep), and ensuring the ramps available meet accessibility requirements. The short-term recommendations map and list in Appendix C notes ramps that do not have truncated dome detectable warning surface (DWS) treatments (as required by PROWAG). Areas that do not meet accessibility standards should add signing to direct trail users to an alternate, accessible route. This is shown in the third recommendation related to improved accessibility: addressing the stair access to the trail at Washington Boulevard. These stairs are currently inaccessible for many trail users, and there are proposed short-term priorities:

At Vermont Street

At 20th Street

By Washington Boulevard

1. Adding a bike runnel to the stairs to make walking a bike on the stairs an easier and less physically demanding process; and
2. Signing alternative routes to enable trail users to avoid the stairs entirely. Suggested routes include directing users via Abingdon, 13th Street, and Buchanan or Aberdeen

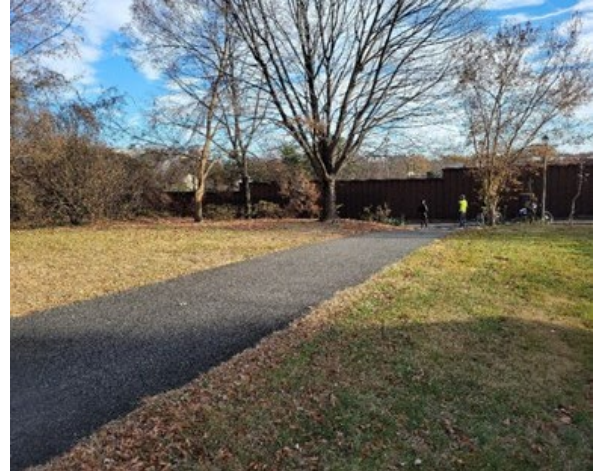
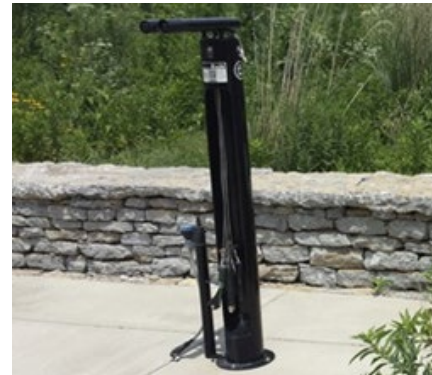
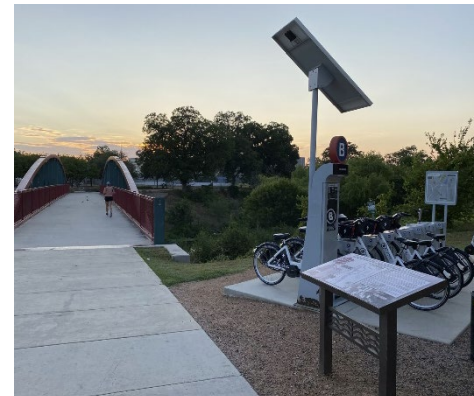
Figure 66 Trail Amenities

Park area (by Segment 3)

Bicycle repair station

Bikeshare station

- **Seating and tables** (e.g., picnic tables; this can also include transit shelters with areas for waiting if applicable);
- **Educational and informational signage** (including maps or other wayfinding details), especially at trailhead locations;
- **Drinking fountains and water refill stations** (where existing water pipes are available);
- **Trash and recycling receptacles;**
- **Bicycle parking**/bicycle racks, and other parking accommodations including vehicle parking and micromobility parking;
- **Bike share docks** (e.g., Capital Bike Share);
- **Bicycle repair stations** including features such as air pumps or wheel patches;
- **Restrooms** or wayfinding to nearby public restrooms.

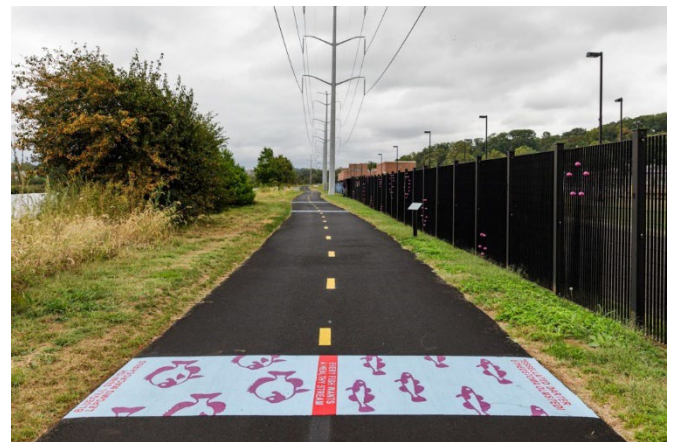
**Figure 68 Watermarks Thermoplastic Art Installation**  
(Source: Elman Studio, via Arlington County)

These features can serve deeper value as wayfinding or educational tools and encourage new visitors to the space. For example, the County's Four Mile Run Trail features a pavement art installation, "Watermarks" (Figure 68) which serves to remind riders of the water resources below and surrounding the trail. This form of installation can help interpret and celebrate the natural environment and connect trail users with their surroundings and is highly encouraged in both the County's FNRP and Public Spaces Master Plan.
